**A HUMAN FACTORS ANALYSIS OF
HIGHWAY-RAILWAY GRADE CROSSING
ACCIDENTS IN CANADA**

Prepared for
Transportation Development Centre
Transport Canada

by
Cognitive Ergonomics Research Laboratory
Department of Psychology, University of Calgary

September 2002

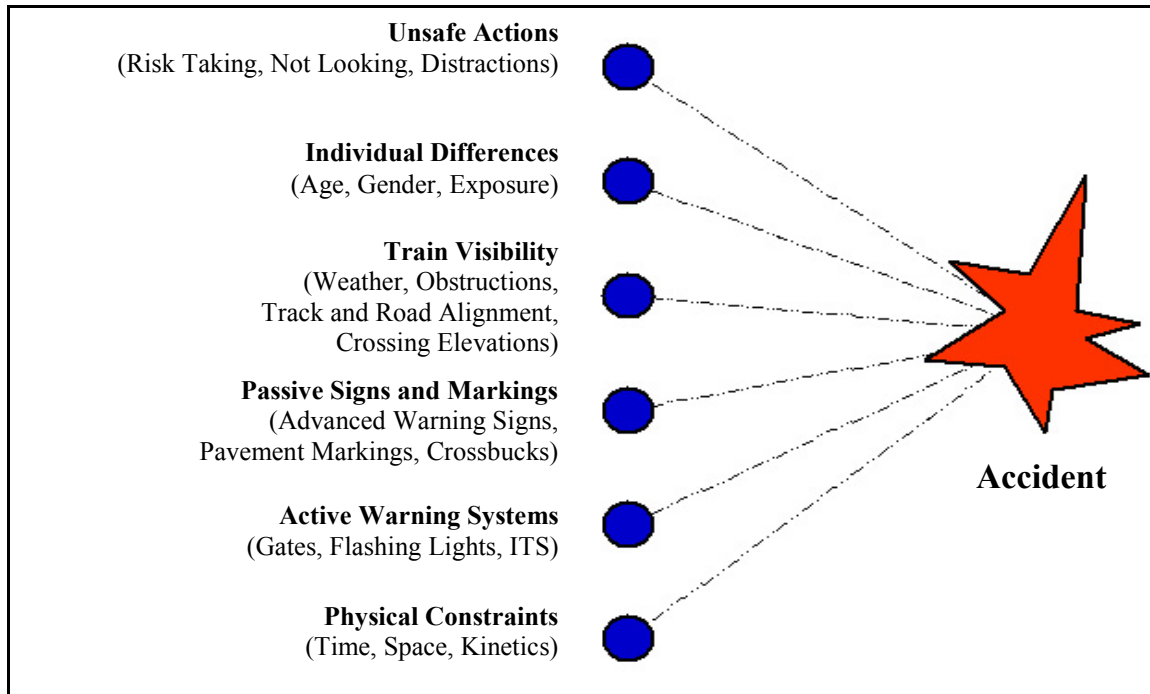
Figure 1 Highway-railway grade crossing accident contributors.

One purpose of this project was to extend what is known about highway-railway grade crossing accidents to Canadian data. Based on an extensive literature review, a taxonomy of highway-railway intersection accident contributors was created to generate hypotheses and deductions about specific cases and common patterns of accident contributors (see Figure 1). Unsafe acts, individual differences, train visibility, passive signs and markings, active warning systems, and physical constraints form the primary categories of accident contributors. Unlike other taxonomies, emphasis is placed on multiple contributors to accidents.

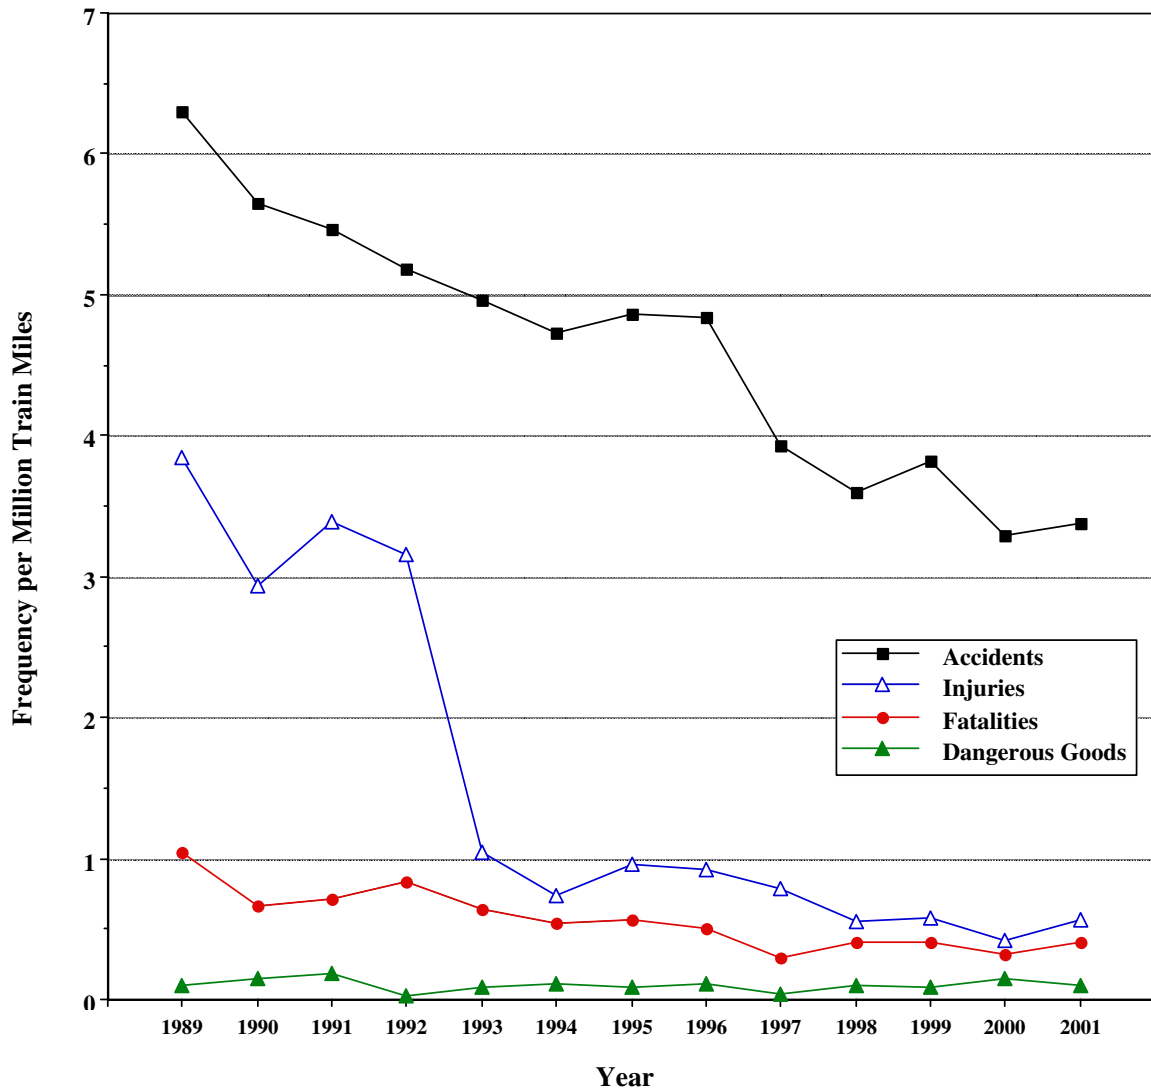
Figure 2 Frequency of accidents, injuries, fatalities, and dangerous goods per million train miles from 1989-2001.

Accidents at both public automated and public passive crossings have declined since 1983, and public automated crossings experienced more accidents overall than any other type of crossing. After 1993, all private and farm crossing accidents were required to be reported, and show an increase in accidents that is reflective of the reporting change.

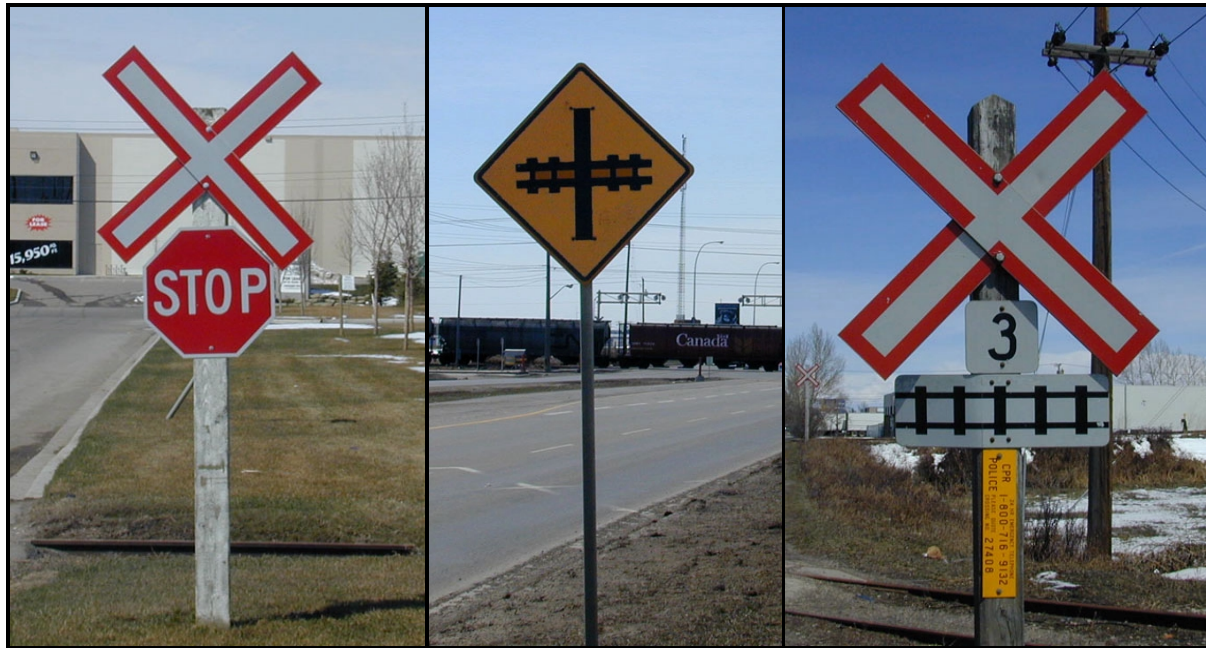
Figure 2.1 Advance Warning Signs: crossbuck (RA-6) with stop sign, advance warning sign, crossbuck with multiple track signage (RA-6s).

yellow background (e.g., see W18-20, MUTCDC). Variations of the sign indicate the location of the tracks relative to an intersection (see Figure 2.1). AWS's (WA-18R) depicting the railway track crossing the roadway at an angle are used at skew-angle crossings, since those configurations can present visibility problems. An advisory speed tab sign may also be placed below the AWS to indicate a recommended vehicle velocity when sight distances are limited.

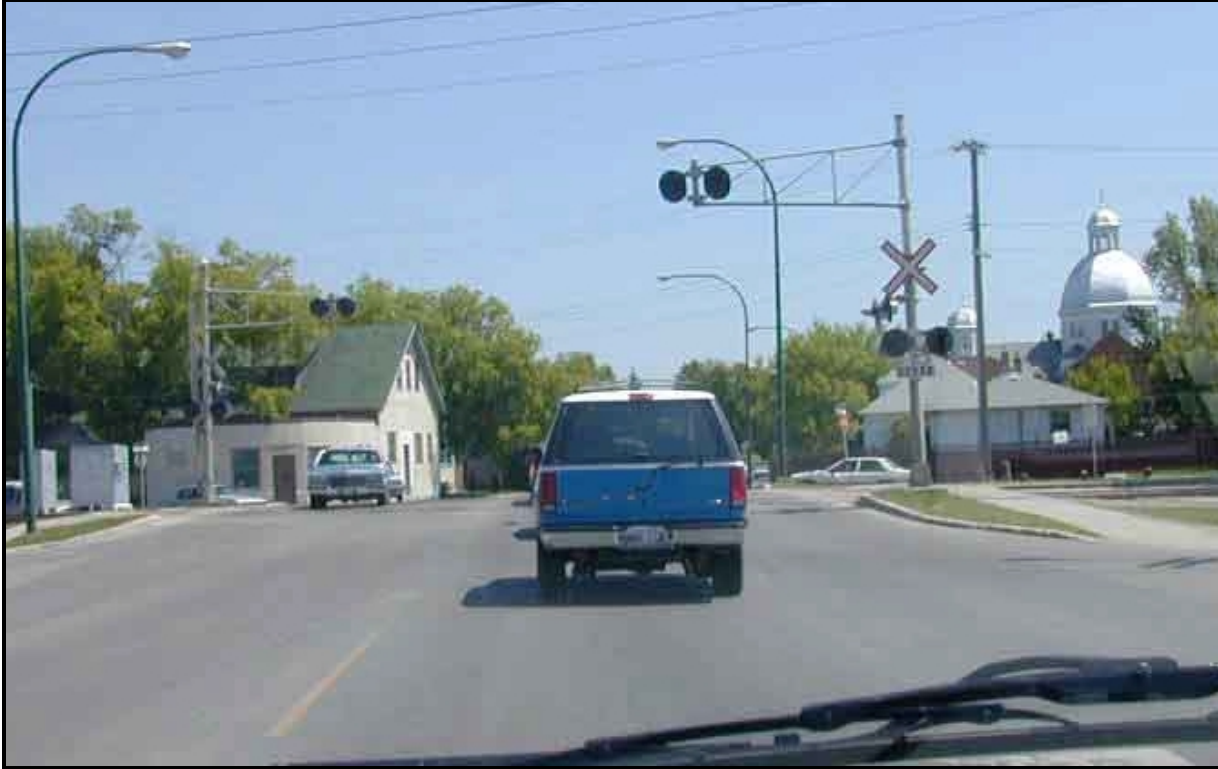
Figure 2.2 Crossbuck, lights on a pole and cantilevered over the roadway, 2-track sign and overhead lights in suburban Winnipeg.

Crossbucks are located at all grade crossings on both approaches to the crossing. They are intended to indicate that drivers must yield the right of way to trains. The crossbucks form an X via the intersection of two 1200 mm x 200 mm retro-reflective pieces and are attached to a post also marked with retro-reflective material. The post height depends on the environmental conditions associated with each railway grade crossing. Multiple track signage is required when there is more than one track present and is attached below the crossbuck sign.

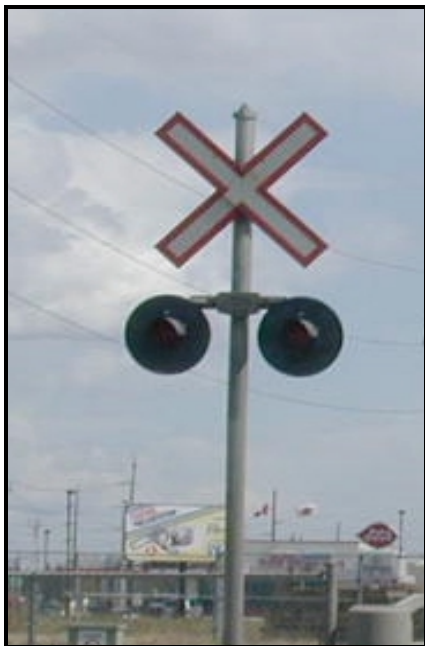
Figure 2.3 Automated warnings: crossbuck sign with flashing lights.

The primary warning devices at active crossings are flashing red lights. These are either 20 or 30 cm (8 or 12 in.) in diameter. The latter are somewhat more effective, as they have an area of more than double the 20 cm (8 in.) lights (Glennon, 1996). A limitation of these lights is that

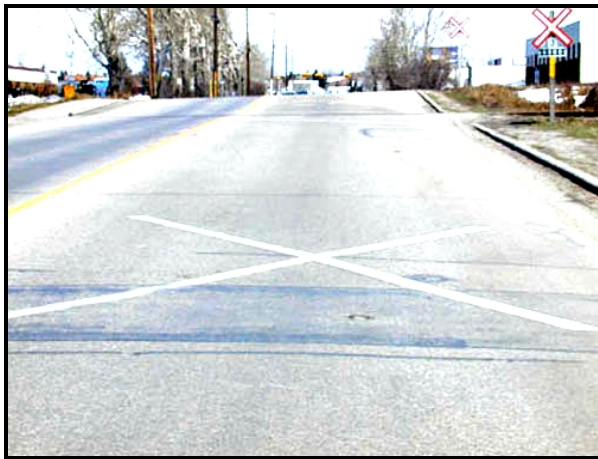
Figure 2.4 Highway pavement markings before crossing.

Pavement markings are painted on the roadway just past the AWS and before a highway-railway crossing. The pavement markings consist of a large “X” with a stroke width of 300 to 500 mm. Dimensions of the “X” are 6.0 m long and 2.5 m wide. Retro-reflective paint must be used and the “X” must be incorporated on each side of the road before the railway grade crossing. The centre of the cross marking is located 10 m from the AWS.

Two white stop lines across the width of the driving lanes, 300 mm wide and 300 mm apart, at a distance of 4.5 m from the nearest track indicate where drivers are to stop when a train is approaching.

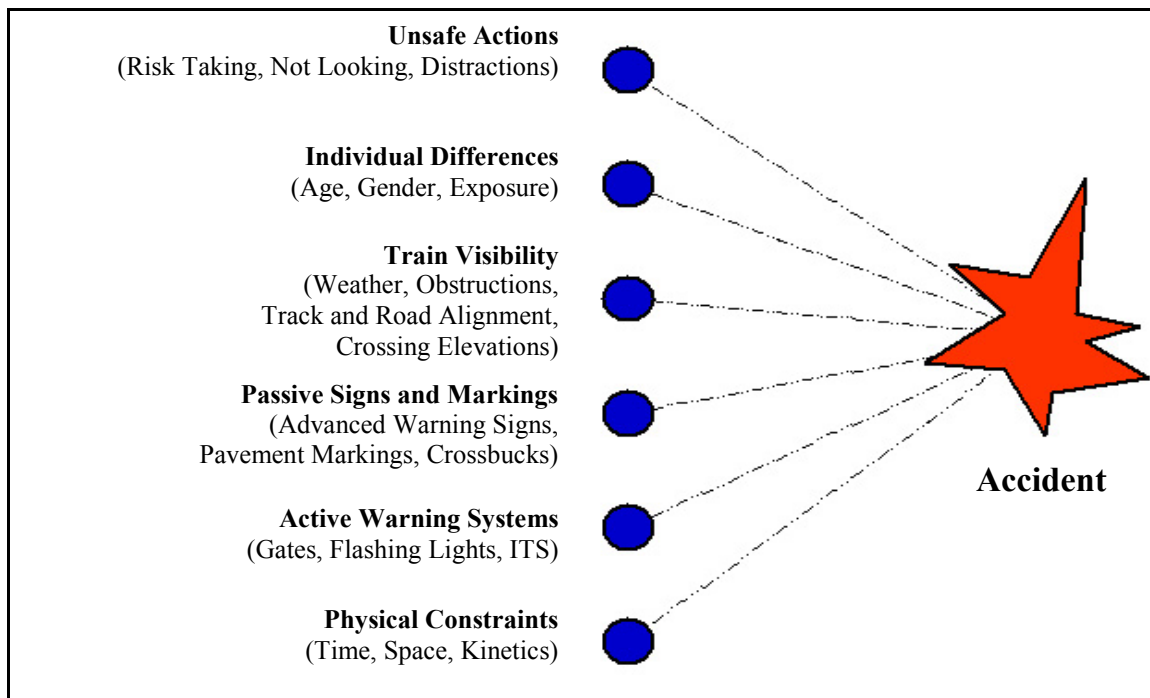
Figure 4.1 Taxonomy of highway-railway grade crossing accident contributors.

inadequate information processing by the vehicle driver, while the latter involve specific driver characteristics and capabilities that influence driver decision making and behaviour. Human actions (including driver limitations and impairments) and individual differences that interact with the roadway environment (including traffic control devices) come into play when one considers train visibility, physical constraints, and effectiveness of traffic control devices (warning systems, signs and markings). Human factors (driver action and capabilities) interact with these physical factors, including environmental conditions such as weather and darkness, to influence safety at crossings. In view of the evidence that up to 90% of roadway accidents involved human error or inappropriate behaviour as a contributing factor (Treat, et al., 1979), it is essential to understand driver perceptions and actions in examining safety at highway-railway grade crossings. A pure mechanical failure leading to a vehicle-train collision is less likely (e.g., see Treat et al., 1979).

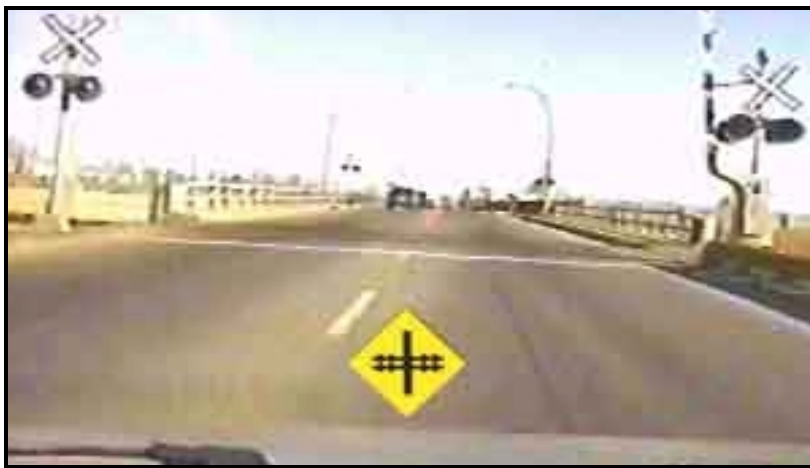
Figure 5.1 Head-up display of in-vehicle train warning used in Chugh and Caird (1999).

Chugh and Caird (1999) assessed the potential of an in-vehicle train warning (ITW) presented in a head-up display (HUD) to convey highway-railway advance warning information. In addition, the effect of the reliability of the system on driver response time and trust was assessed. Thirty-six participants ranging in age from 18 to 26 years volunteered for the study. On average, participants drove about 15,000 km per year. A modified rail AWS was presented as a HUD overlaid on digitized driving films (see Figure 5.1). Using a low-fidelity driving simulator, participants responded to a limited number of events by using a steering wheel, brake, and accelerator pedal. For example, the participant could use the pedal and accelerator to achieve three film speeds that mimicked hard and soft braking and accelerating. Digitized driving films were projected 3.5 m in front of the participants onto a screen. A total of eight highway-railway grade crossing approaches were filmed. Each crossing was filmed in summer and winter conditions, yielding a total of 16 two-minute films. Clanging bells were added to the sound track as a driver approached a crossing. The ITW was presented for 2.5 seconds about 10 seconds prior to each highway-railway crossing.

To determine reliability effects on behaviour, participants were randomly assigned to either 50% or 83% reliability condition. Type of failure was also manipulated within-subjects. The ITW was presented when no crossing was present (i.e., false alarm) and not at all before a crossing (i.e., missed signal). Each participant “drove” a total of 24 video sequences. Each sequence consisted of an approach to a railway grade crossing intermixed with driving through urban and suburban traffic environments. Participants were instructed that the ITW informed them of a potential approaching train. All participants were instructed to drive normally and to slow down for railway grade crossings.

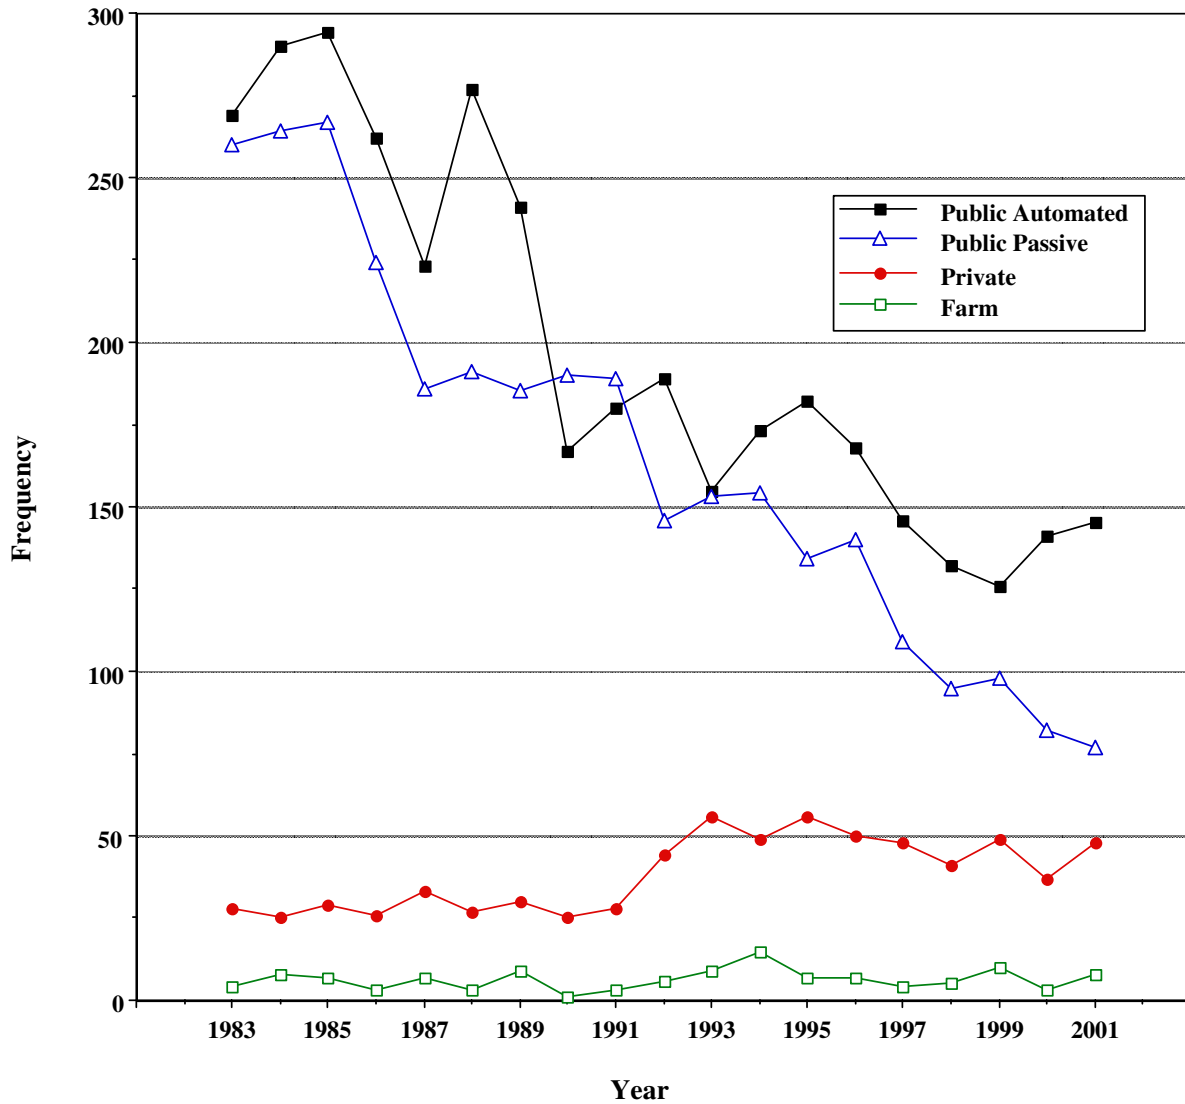
Figure 6.2 Accidents by crossing type per year from 1983 to 2001.

Like total accidents, public automated and public passive warning accidents have declined by approximately half over the past 19 years (see Figure 6.2). The increase in private crossing accidents in 1993 reflects changes in the reporting requirements. Prior to 1993, only private and farm crossing accidents were reported if they involved casualties (minor/serious injuries or fatalities) or a derailment resulting in property damage worth \$7,350 or more for main-track operations. As of 1993, all private and farm accidents must be reported.

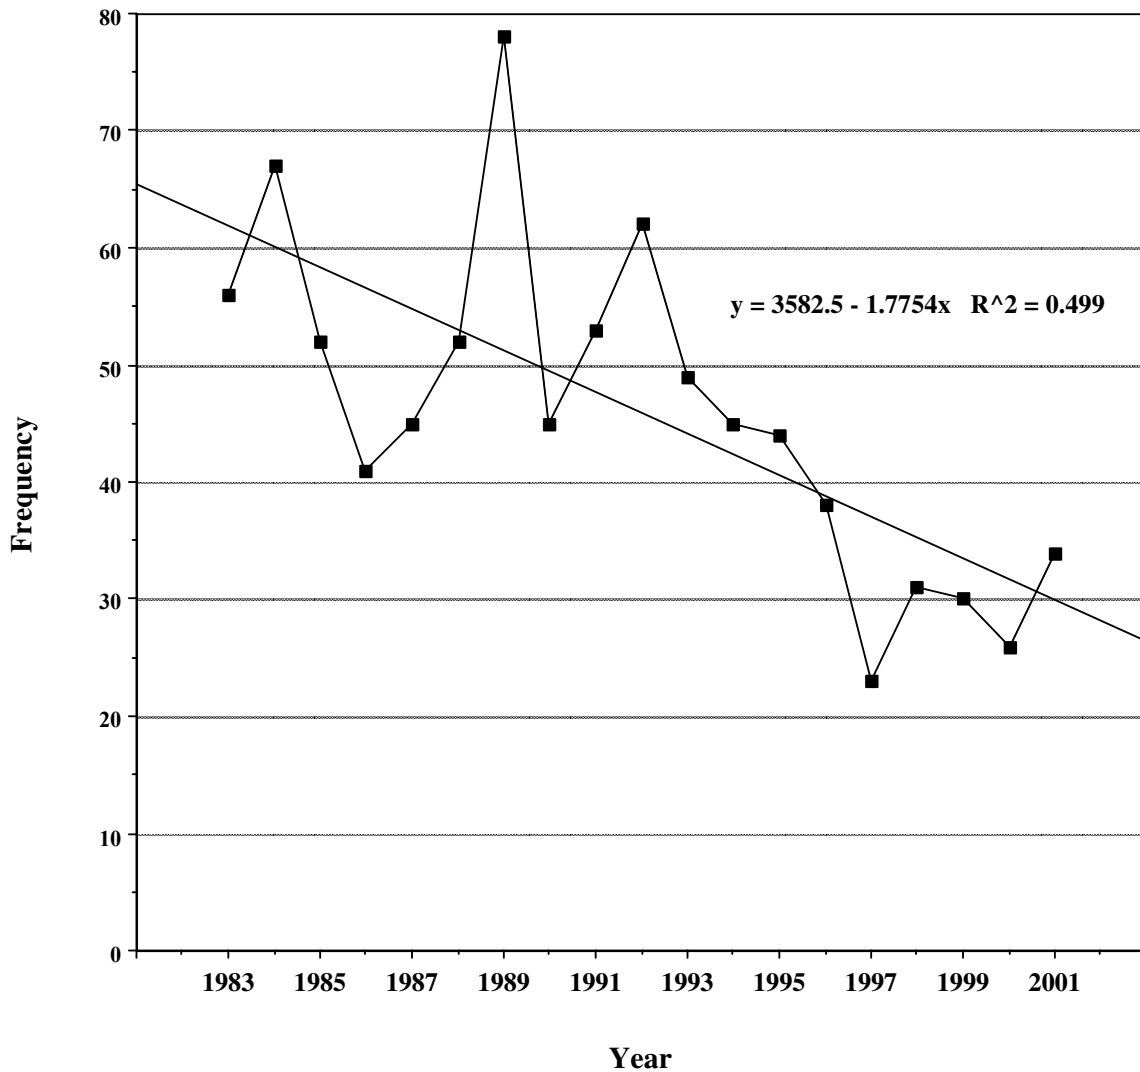
Figure 6.3 Total accident fatalities from 1983 to 2001.

Between 1983 and 2001, an average of 46 vehicle occupants were killed each year in Canada from highway-railway grade crossing accidents. Total occupant fatalities from 1983 to 2001 are shown in Figure 6.3. From 1983 to 1992, of the 551 vehicle occupant fatalities that occurred, 541 were classified as drivers and 10 as passengers. From 1993 to 2001, 246 were classified as drivers and 74 as passengers. The linear regression equation does not fit the data well ($R^2 = 0.50$). The years 1989 and 1992 reflect highs, whereas 1986 and 1997 reflect lows. Fatalities per year vary around the regression line, which attempts to fit the highs and lows.

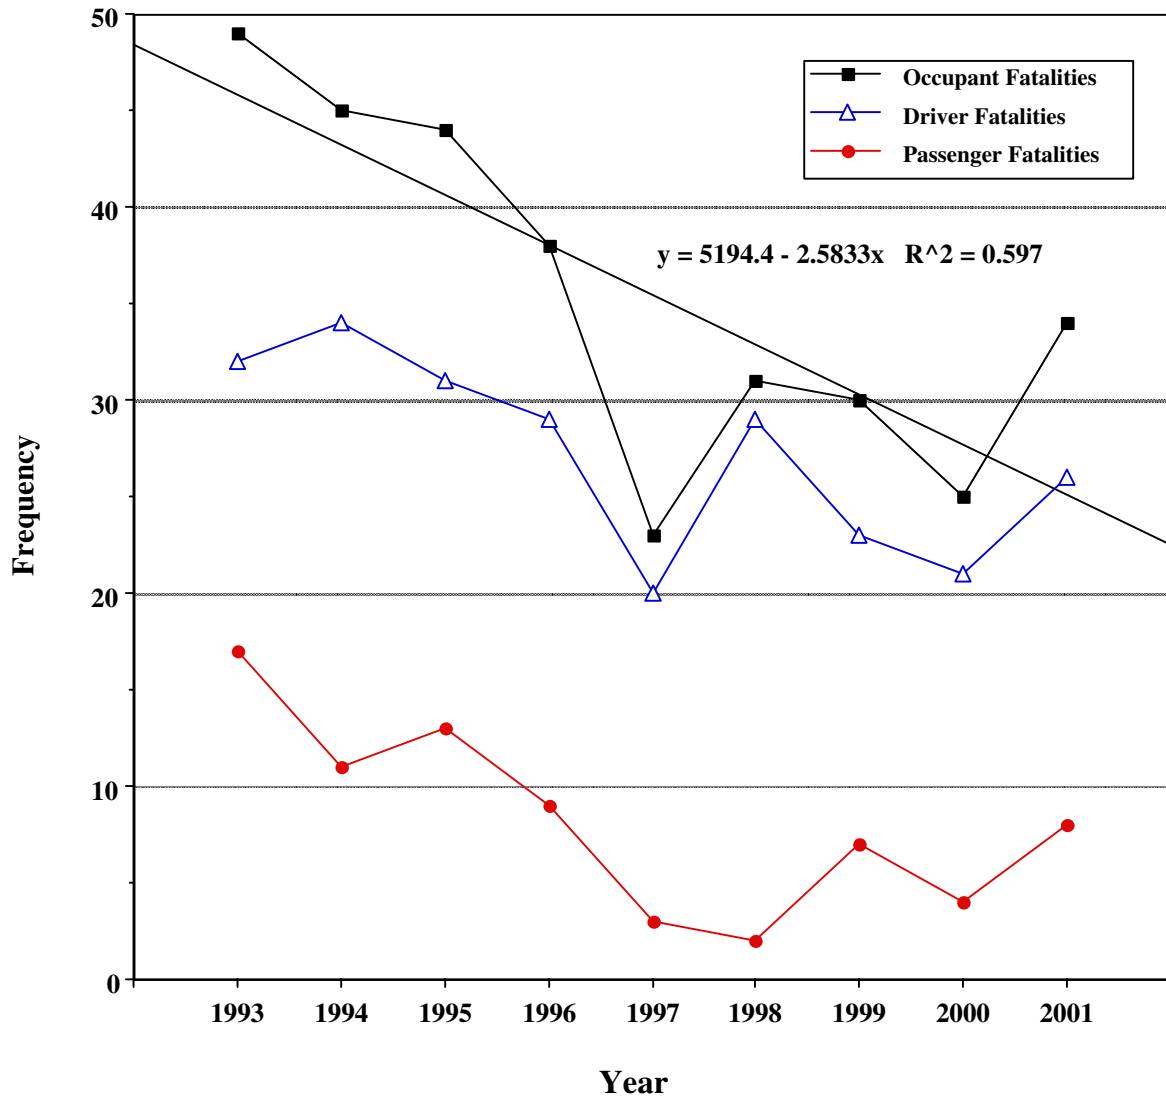
Figure 6.4 Vehicle occupant fatality types from 1993 to 2001 (N = 320).

The frequency of vehicle occupant fatalities per year has declined from 1993 to 2001 (see Figure 6.4). These numbers do not include pedestrian or trespasser fatalities. In general, fatality data are assumed to be somewhat more complete and accurate. Over this period a total of 320 fatalities occurred. The average number of drivers and passengers who died in highway-railway crossing crashes annually was 27 and 8, respectively. In 1993, 49 people died in crossing accidents compared to 34 in 2001. Classification of fatalities into driver and passenger categories was not consistently performed until 1993. Both fatality types have declined from 1993 to 2001. To predict the future number of fatalities per year, a linear regression equation was fit to all fatalities

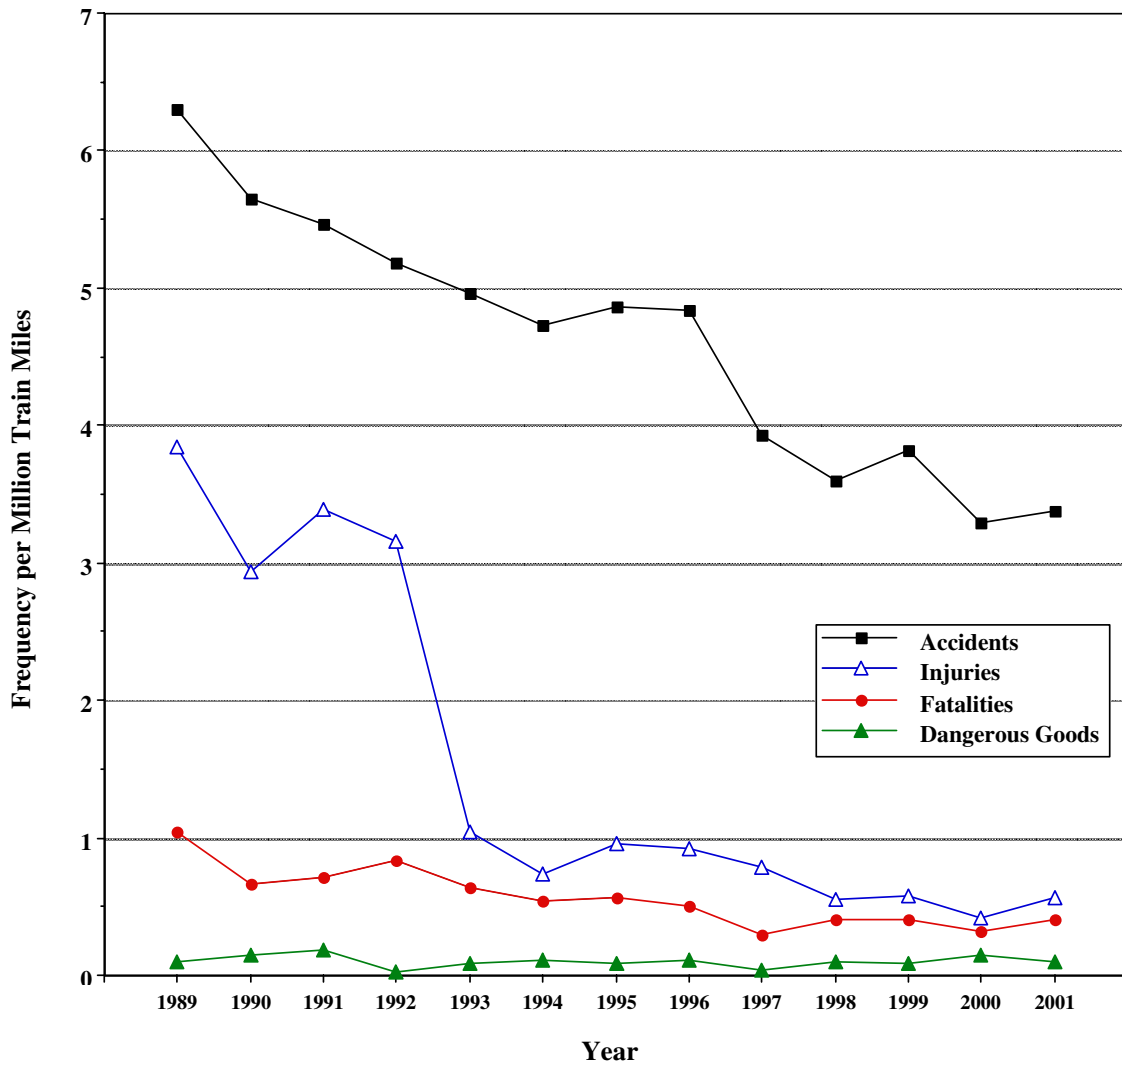
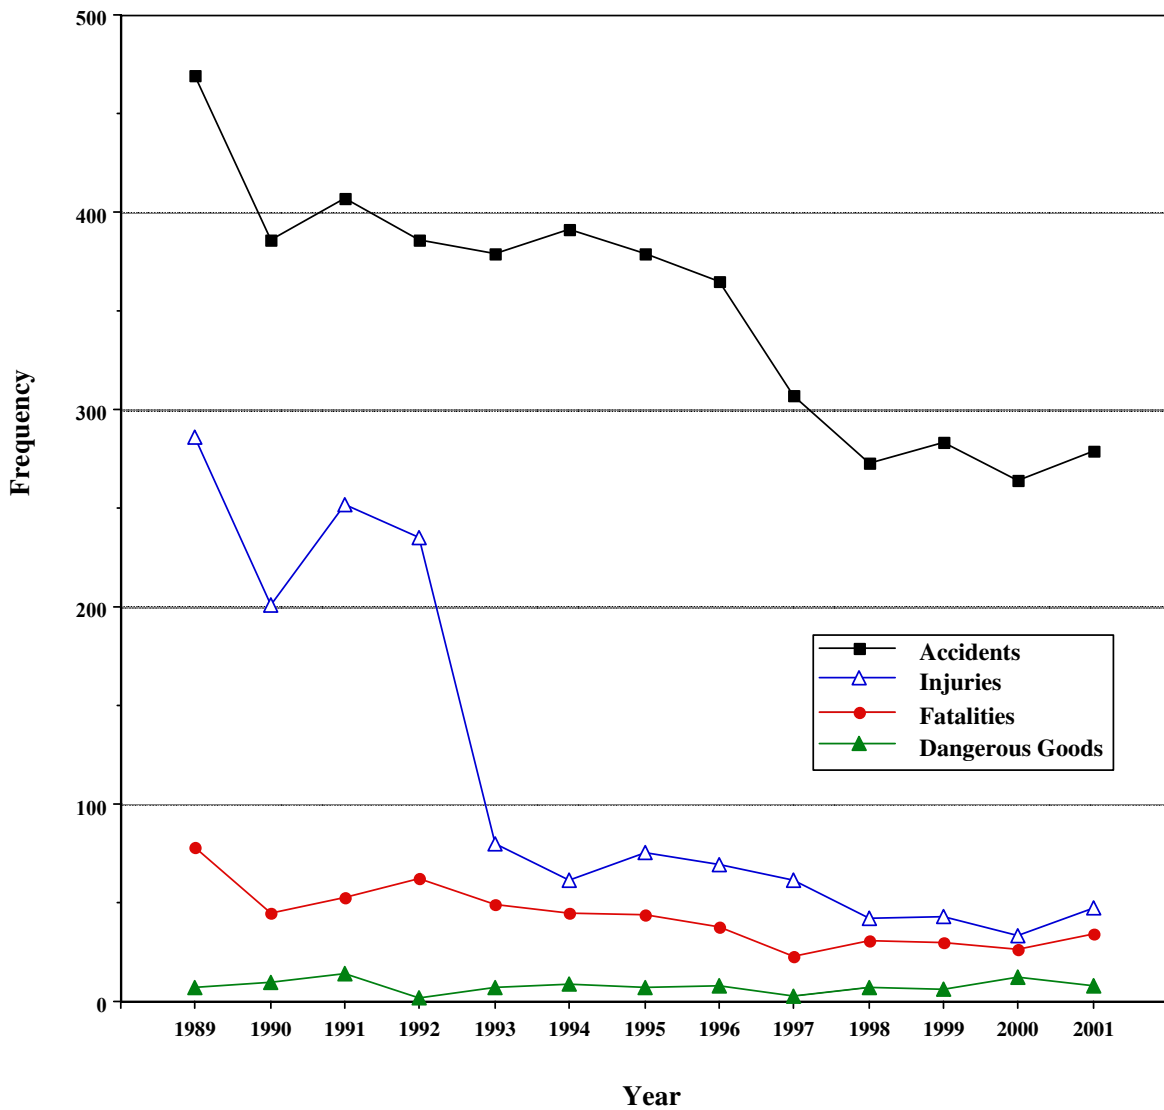
Figure 6.5 Accidents, injuries, fatalities, and dangerous goods per million train miles from 1989 to 2001.

Figure 6.6 Frequency of accidents, injuries, and fatalities from 1989 to 2001.

Figures 6.5 and 6.6 illustrate accidents, injuries, fatalities, and dangerous goods expressed as frequency per million train miles (MTM) (6.5) and as a frequency (6.6). The dramatic drop in injuries between 1992 and 1993 is indicative of a change in classification criteria. The reporting criteria were changed by the TSB in 1993 from all injuries to just serious injuries. Accidents, injuries, and fatalities show declines from 1989 to 2001, while dangerous goods accidents remain constant.

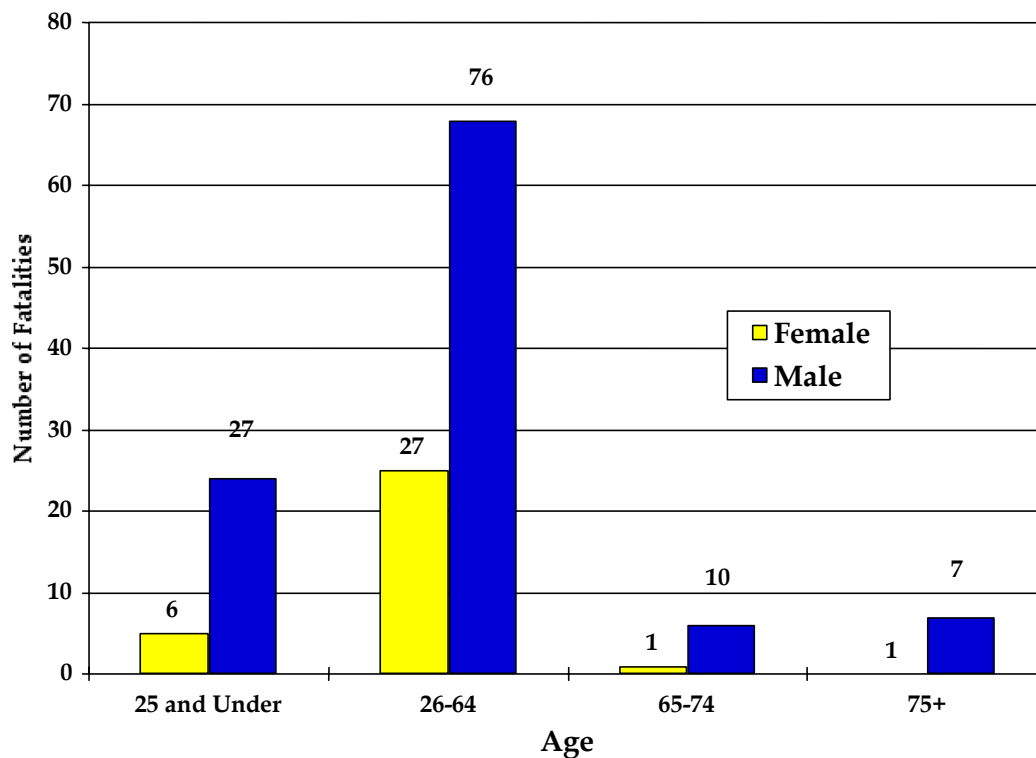
Figure 6.7 Fatalities by age and gender from 1993 to 2001 (N = 155).

From 1993 to 2001, a total of 155 fatalities occurred where the gender and age of the occupant were known. Figure 6.7 shows the number of fatalities for each age group and gender. In this

small sample, males were involved in 77.4% of crossing fatalities, whereas females were in only 22.8%. In all age groups, the frequency of male fatalities is higher than that of female fatalities. The age group of 26 to 64 accounted for 66.5% of all fatalities. This age proportionally drives the most and thus has the greatest exposure (Evans, 1991). To determine why males are killed more frequently requires exposure data on both men and women. Do men use railway crossings more frequently, less safely or both? Cautious interpretation of this data is warranted. A similar pattern of male involvement was reported by the FRA statistics (FRA, 2001). However, fatalities by age group in the FRA incident data (2001) for the year 2000 are categorized by under 16 (N = 61), 16 to 21 (297), and over 21 (425). This classification scheme indicates a potential problem for younger drivers, but does not provide a means to understand the accidents of drivers over 21.

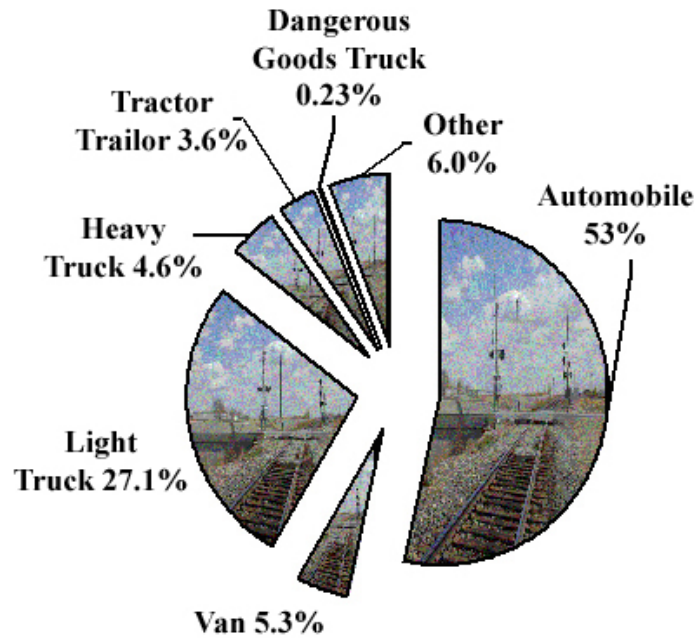
Figure 6.8 Vehicle occupant fatalities by vehicle type from 1983 to 2001 (N = 871).

Figure 6.8 illustrates the vehicles that were involved in fatalities over the past 19 years. Automobiles were involved in 53% of crossing fatalities from 1983 to 2001 (N = 871). Light trucks, tractor trailers, heavy trucks, and vans comprised 40% of fatalities. Light trucks, which

were involved in 27% of fatalities, typically operate in rural and industrial urban areas where more tracks are present. Dangerous goods trucks were involved in 2 fatalities (0.23%) from 1983 to 2001 (e.g., see TSB 1993, October). Similar vehicle involvement percentages occurred in the U.S. (FRA, 2001). The other category includes motorcycles, bicycles, emergency vehicles, snowmobiles, all-terrain vehicles, graders, farm tractors, farm equipment, and wheelchairs.

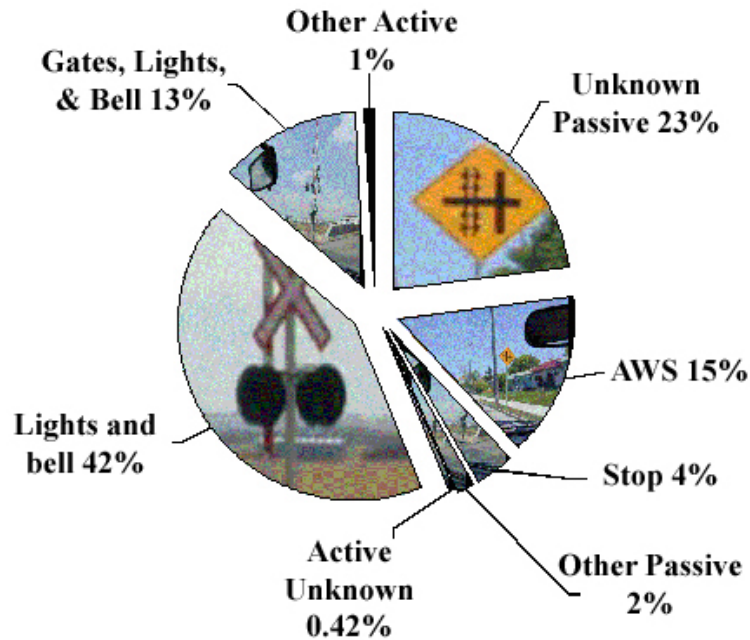
Figure 6.9 Percent of accidents for each type of sign and signal from 1992 to 2001

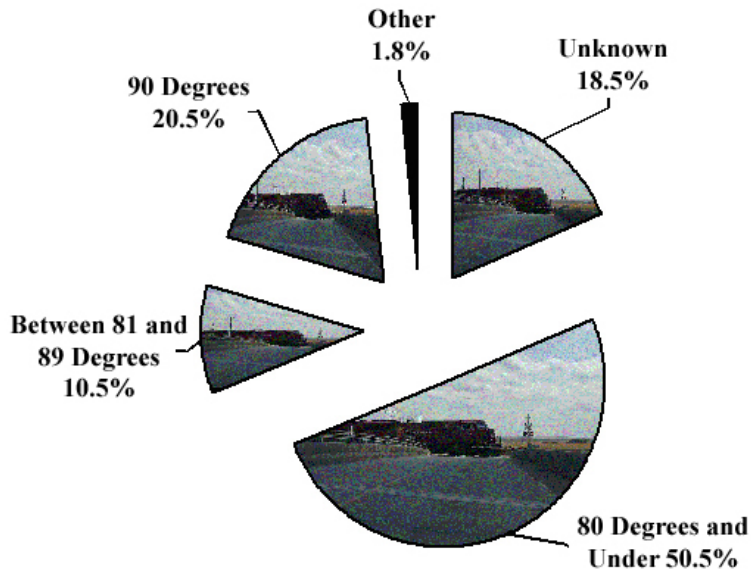
Figure 6.10 Crossing accidents by angle from 1983 to 2001 (N = 7,819).

Highway-railway grade crossing angles may contribute to train visibility difficulties (Mortimer, 1988). Within RODS, crossing accidents were the most frequent for crossing angles of 80° or less (or more than 100°). The crossing accidents were cross-referenced with Transport Canada's Integrated Rail Information System (IRIS) database to obtain angles for the crossings (see Figure 6.10). The angles provided by both RODS and IRIS are usually the crossing angles (i.e., smallest angle) and not necessarily the accident angle. For example, fewer than 100 of the accident crossings in RODS have an angle greater than 100° .

The IRIS information indicates that more than half of accidents happened where the intersection angle was 80° or less. Where tracks and roadway are perpendicular, the angle is 90° . An 80° intersection could also be 100° (opposite angle). Although this information cannot really be interpreted in context, more accidents happen at crossings with angles below 80° and greater than 100° .

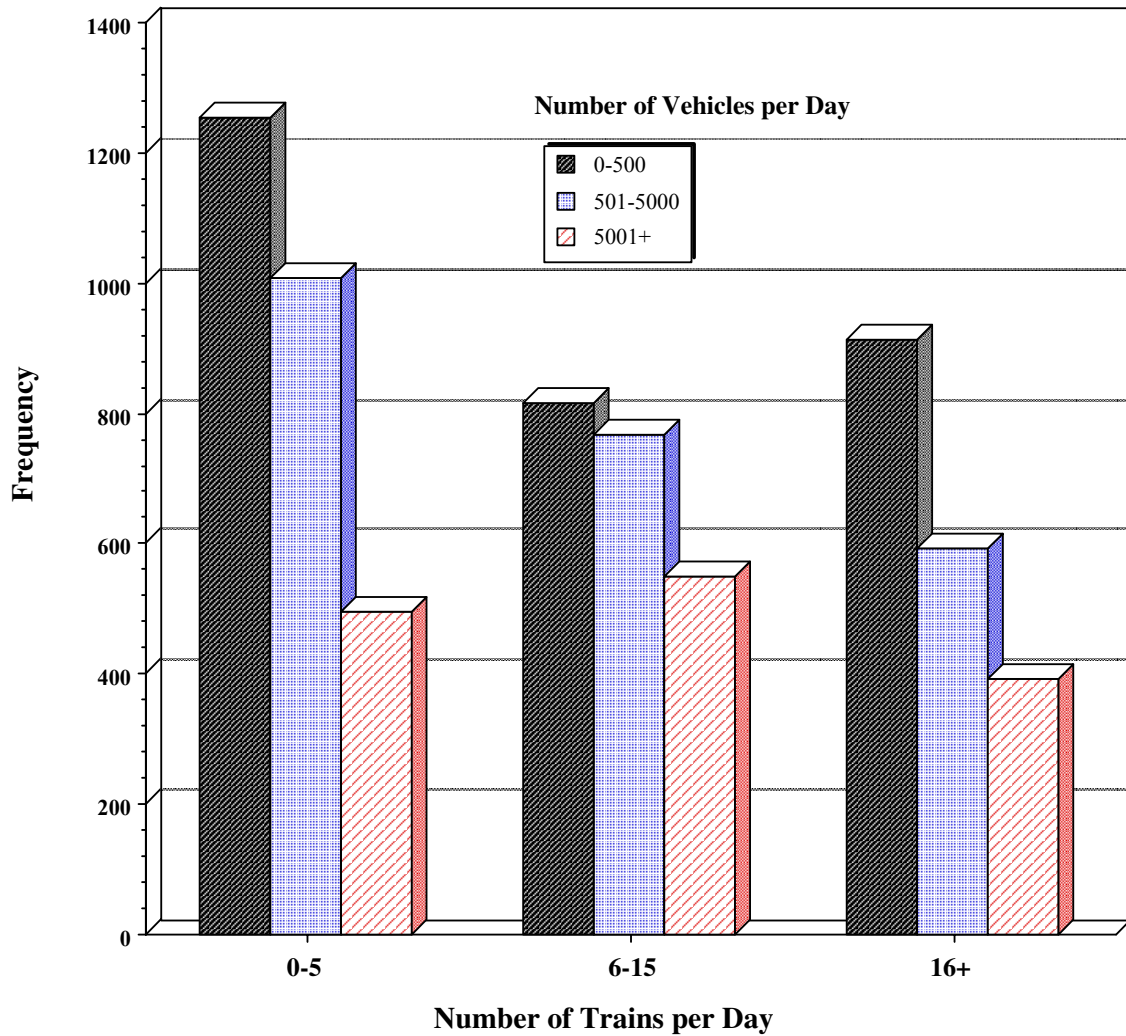
Figure 6.11 Accident frequency based on vehicle and train flow per day from 1983 to 2001 (N = 6,795).

From 1983 to 2001, lower vehicle flows (0 to 500 per day) seem to be related to higher frequencies of crossing accidents (see Figure 6.11). From 1993 to 2001, 1,262 of 3,264 accidents happened at urban intersections and 1,085 occurred at rural intersections. Where low levels of traffic flow exist, such as at rural intersections, may be where more accidents happen. When traffic flow exceeded 5,000 vehicles per day, accident frequencies were somewhat similar across categories of train flow. Given warrants based on vehicle and train flow discussed in Section 2, crossings with high vehicle flows, high-speed passenger trains, and a history of accidents are more likely to be protected by gates, bells, and lights. Forcing functions such as gates will reduce the probability of crossing accidents. Higher flows in urban areas are more likely to be protected

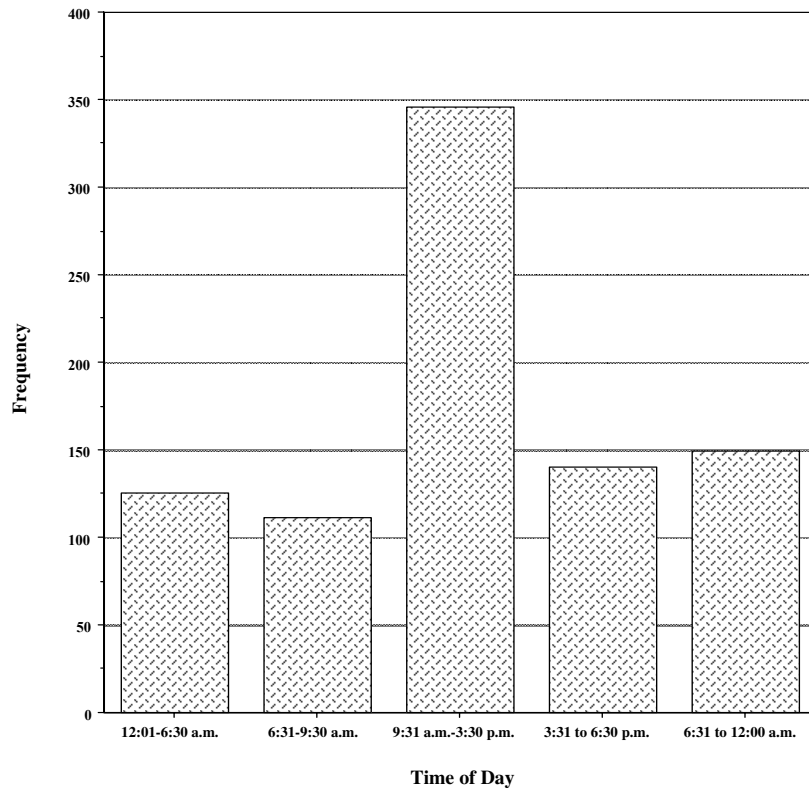
Figure 6.13 Fatality frequency by time of day (N = 871).

The relative number of fatalities is less during the day (9:31 a.m. to 3:30 p.m.) and more in the morning hours (12:01 a.m. to 9:30 a.m.). Figure 6.13, fatality frequency by time of day, is quite similar to 6.12. Fatalities are highest from 9:31 a.m. to 3:30 p.m. The FRA data (2001) indicate that weekdays (Monday to Friday) have the highest total incidents. On Saturday and Sunday, the total number of accidents declines sharply (also see Wigglesworth, 1979).

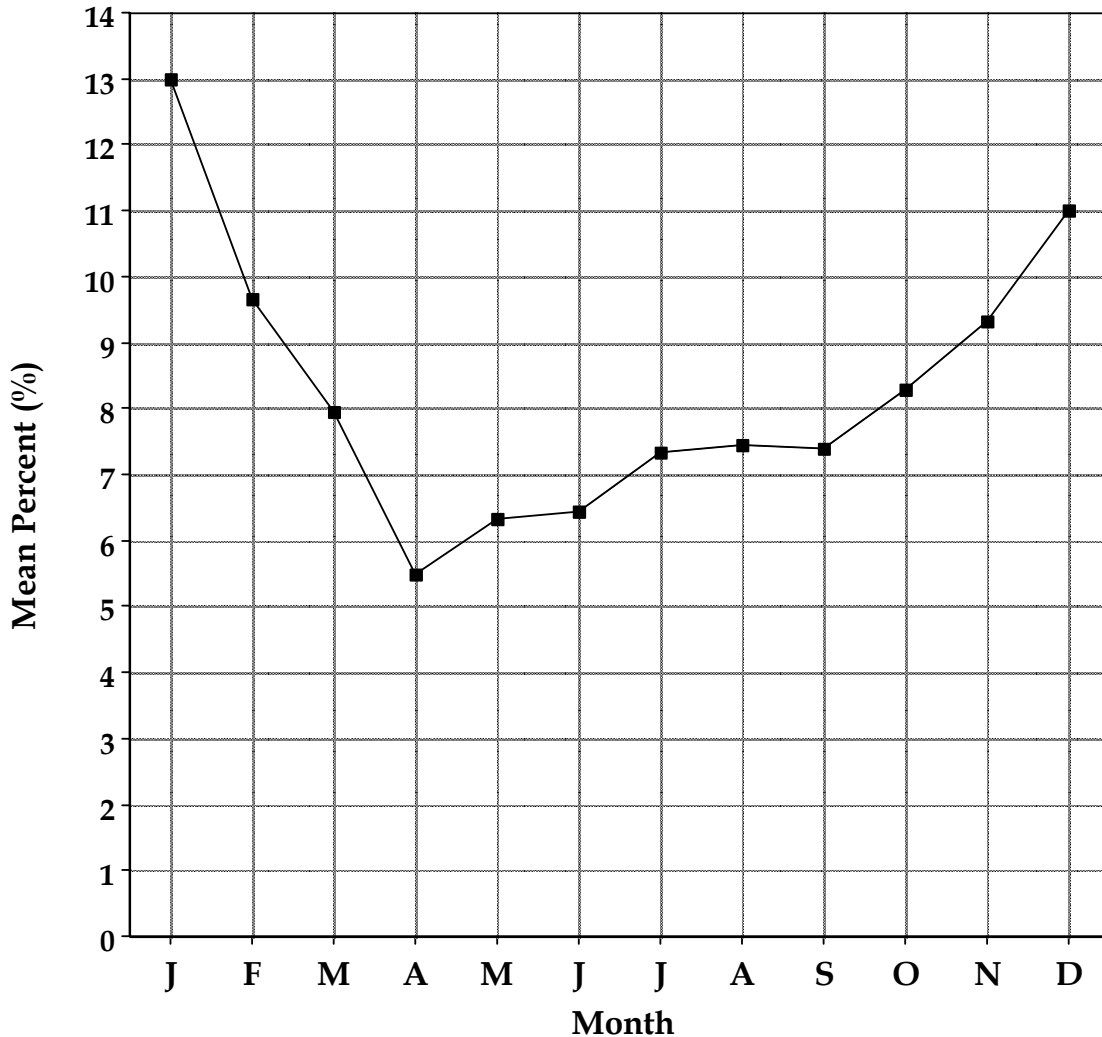
Figure 6.14 Mean percent of accidents by month from 1983 to 2000 (N = 7,541).

Weather patterns within Canada vary from year to year, with a trend toward warmer winters. To reduce the influence of weather from any single year on the frequency of accidents, data from 1983 to 2000 were averaged and the percentage of contribution of each month to the total was calculated (see Figure 6.14). January and December have the highest percent of accidents per year and April has the lowest. The FRA's tabulation of crossing accidents/incidents for 2000 shows the same monthly pattern, with peaks in December and January and a low in April (FRA, 2001).

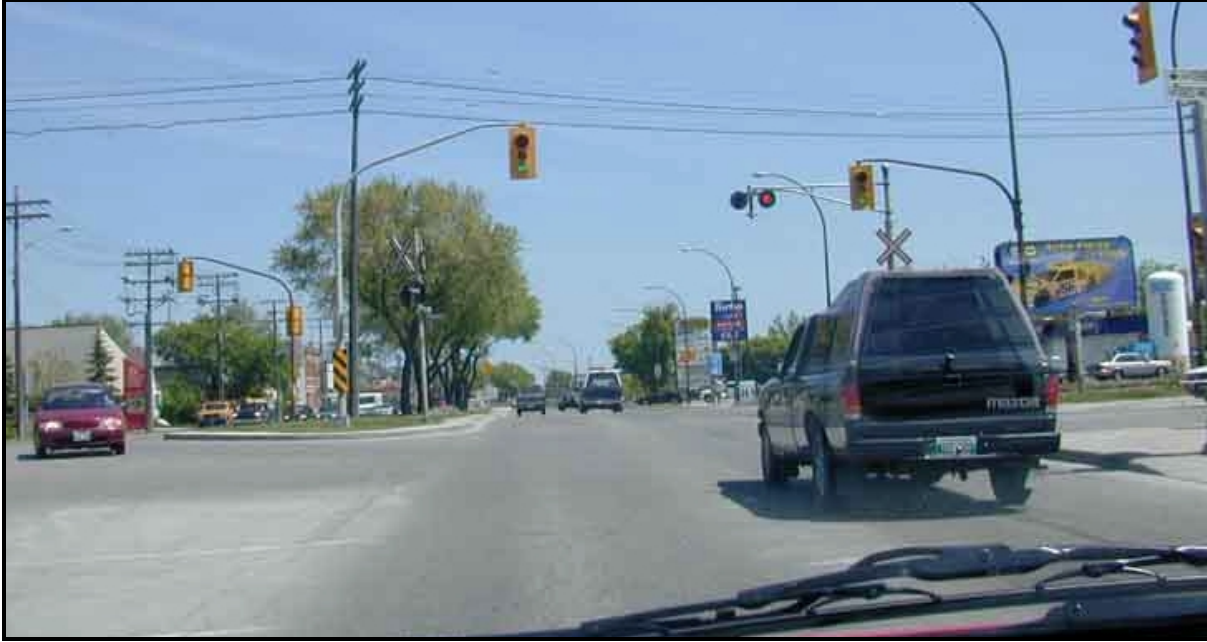
Figure 6.15 An intersection and a grade crossing in close proximity in urban Winnipeg. The visual demand of other vehicles, sign clutter, and signals make decisions to stop more difficult. The synchrony of the intersection lights (green) and crossing lights (flashing red) is not ideal. Interconnection of traffic lights and highway-railway grade crossing signals is suggested (Bremer & Ward, 1997).

Several other questions also could not be completely addressed. Crossings that are in proximity to other intersections are more likely to have accident occurrences (NTSB, 1998a; Wigglesworth, 1979). From 1993 to 2001, RODS returned the frequency of accidents at traffic lights (6), flashing lights and traffic light (8), and FLBs, gates, and traffic light (7). The true extent of this accident type may need police and RCMP collision reports. More importantly, this type of accident configuration was confirmed in the narrative analysis. Figure 6.15 illustrates the potential difficulties faced by drivers at intersections near highway-railway crossings.
